OCTOBER 1967

THE NAVAL AVIATION SAFETY REVIEW

V.13 #4

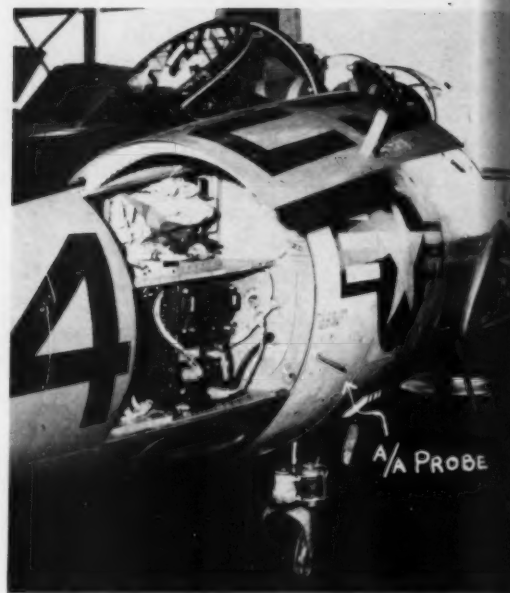
Although the accident was labeled as having occurred essentially of an undetermined cause, there is a strong suspicion that (as it did in a similar daytime incident previous to this) the open nose access door caused erroneous low angle-of-attack increment readings. The instrument's probe is located near the door which, when it is open, is known to disturb the normal air flow over the slots. Consequently, a stall condition rapidly developed before the pilot detected it and the beginning of a spin used up the meager altitude that remained.

The angle-of-attack air flow was disturbed.

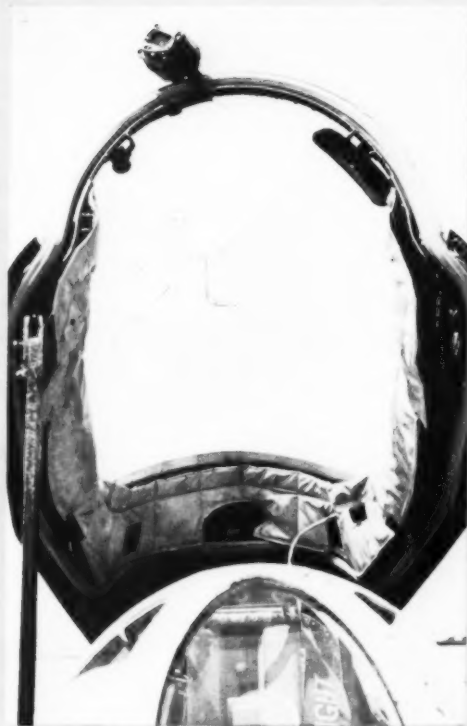
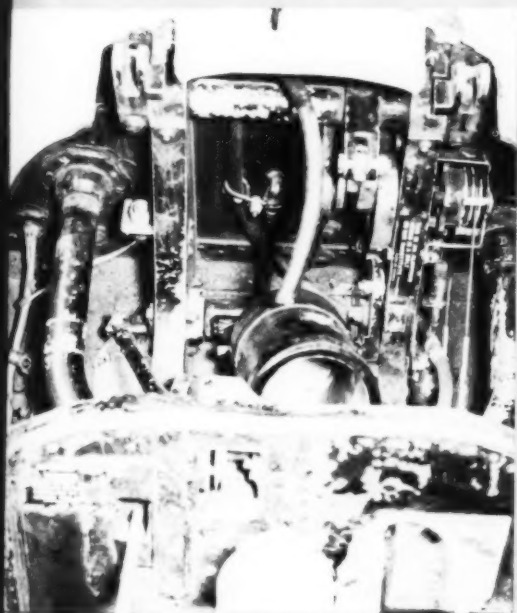
... equals damage.

An unfamiliar cockpit. . .

AN A-4A had been hauled out of mothballs and flown to NARF for PAR. Upon arrival at the destination an assigned line crewman was attempting to insert the canopy pneumatic bungee safety lock. It was an older type with the latch release at the base of the bungee cylinder supported by double retaining straps. Unfortunately, few of the men were familiar with it. Standing on the entrance ladder, the man had the lock in his left hand while trying to insert it into the proper position. Suddenly, the bungee fired with such force that it went through the canopy and another 150'.

The crewman's sound-attenuation ear 'muffs were pulled from his head by the blast and carried 30'. The man received a 5" laceration across his forehead and the thumb of his left hand was broken.

This hazardous design has been corrected in later models of the bungee by putting the latch release at the top of the bungee cylinder where it can easily be seen for placement of the safety pin.

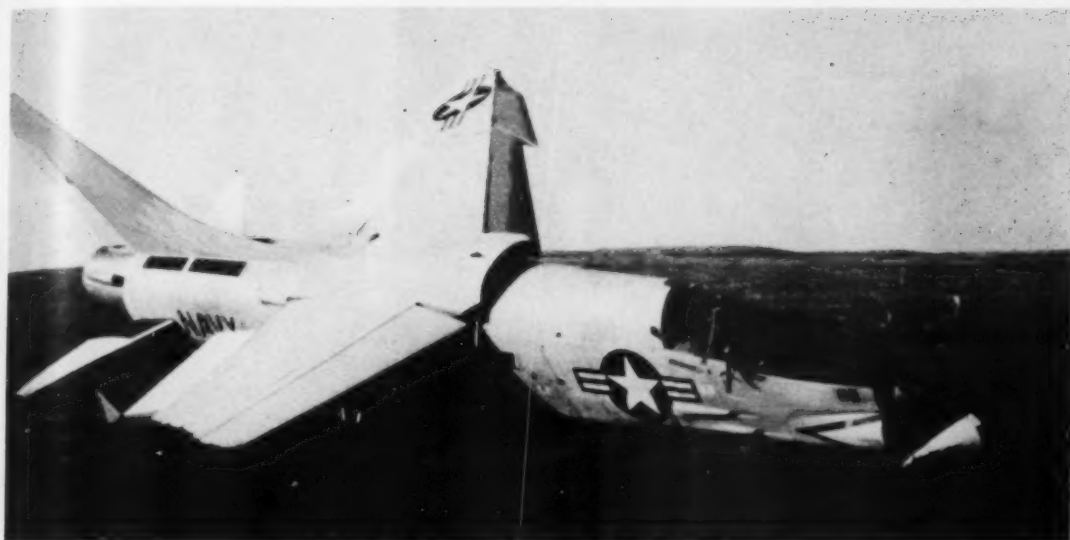
A downwind landing was too much for the Crusader.

about 90 degrees relative to runway centerline. The starboard MLG dug into the loose earth, then the *Crusader* commenced a right roll about the longitudinal axis using the starboard wing tip and nose as pivot points, breaking off the starboard outer wing panel. The aircraft continued corkscrewing, scraped the port wing tip after 270 degrees of roll, and came to rest on the right wing-fold area, right MLG, and nose section. The engine flamed out soon after the aircraft left the runway because of dirt and debris scooped into the intake duct. Pilot X evacuated the aircraft after it came to rest and was not injured. No fire resulted.

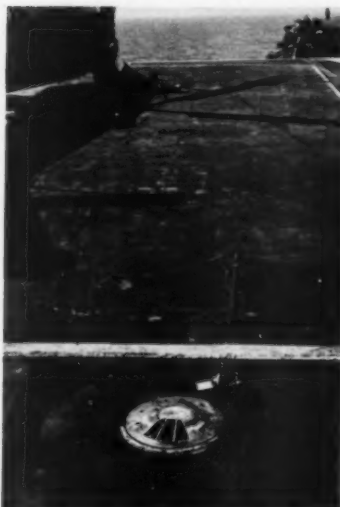
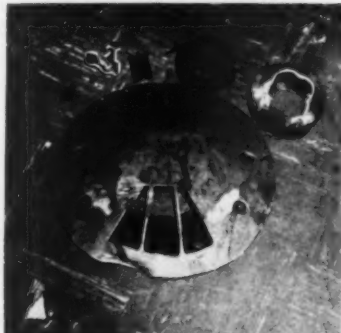
Subsequent investigation revealed that the cover plate had been missing five of the normal 10 securing screws. Upon inspecting other flight deck lighting covers, it was discovered that many screws were missing, probably due to the constant ship's vibrations. As a result, daily inspections have been intensified to ensure the firm security of the very necessary deck lights.

Deck lights are necessary . . .

. . . but they must be firmly secured.

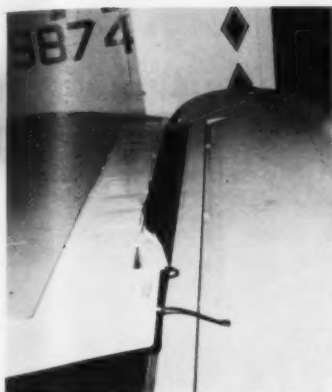
The end result was a bad fit. The spread wing tips put dents into the elevators of two other *Trackers* and all three aircraft were out of action for a few days, while various components were replaced.

Slashed elevators ground airplanes.

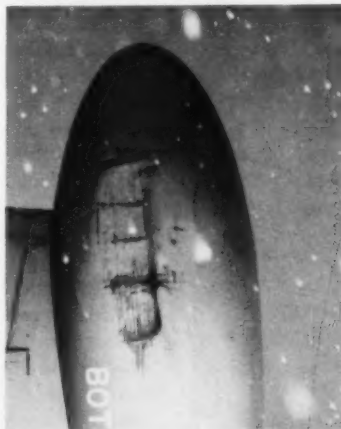
An SP-2E got airborne before dawn in VFR weather, but was quickly engulfed in IFR conditions. Consequently, the pilot made a turn hoping to get back in the clear. He radioed for radar assistance then orbited over the water at 1000'. Upon receiving a radar vector, the turn was stopped and a climb initiated. At 1260', the left side of the *Neptune* dragged through treetops enshrouded in fog. Fortune was with the crew as a hard pullup returned them to unobstructed air. Inflight checks revealed minor damage to the port tip tank, jet engine nacelle and horizontal stabilizer.

Tree damage to the tip tank.

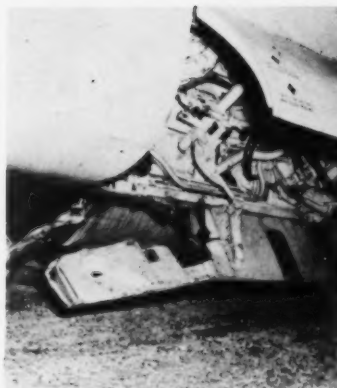
Damage to gear door.

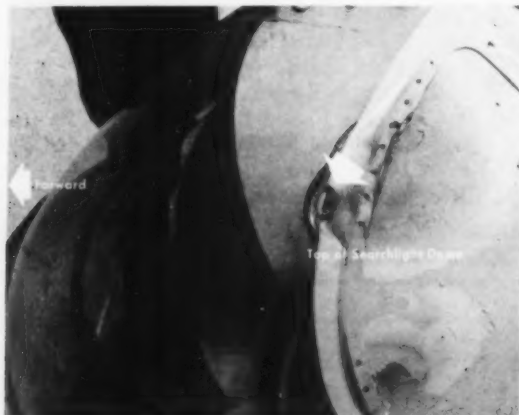
Charred searchlight dome resulting from high tail flame.

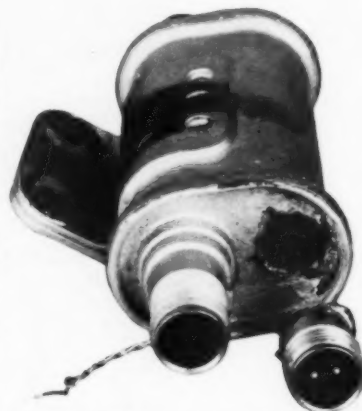
Troubleshooting revealed that the low tension harness plug was broken loose from the high tension coil. (See photo.) This condition was discovered

Paint hid crack in tension coil.
